DAM G

NDI ID NO. PA-00643

HAZLETON CITY AUTHORITY
PHASE I INSPECTION REPORT
NATIONAL DAM INSPECTION PROGRAM

MAY 1979

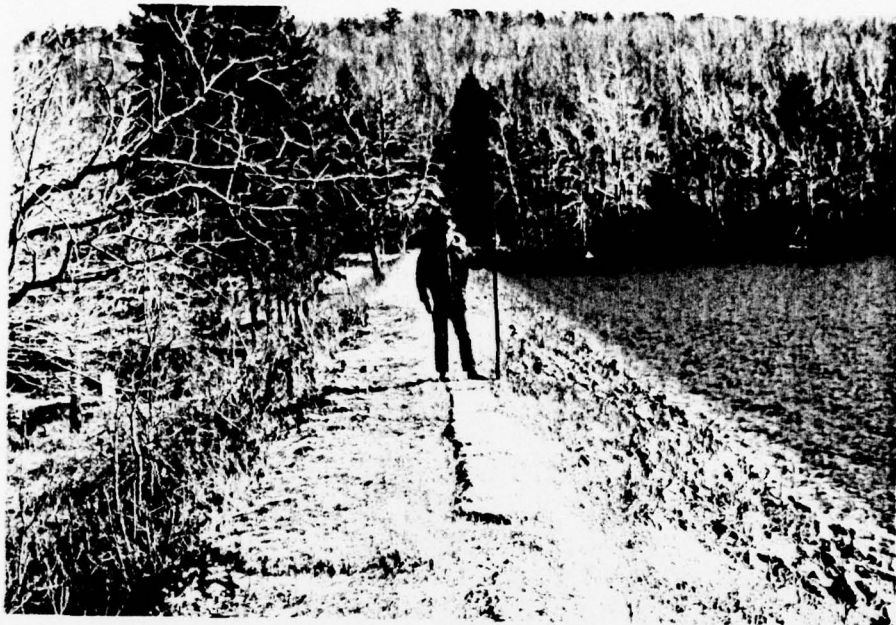
A. Top of Dam

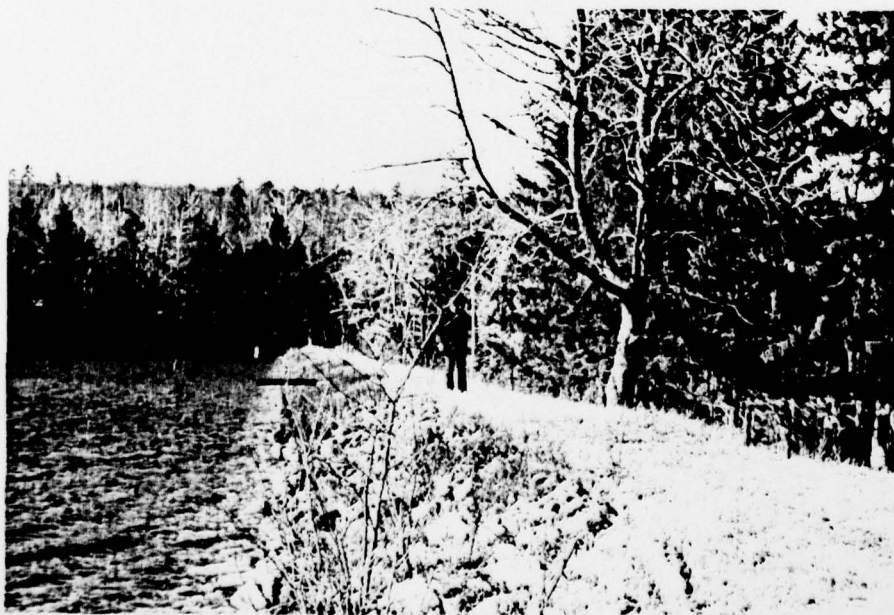
B. Upstream Slope

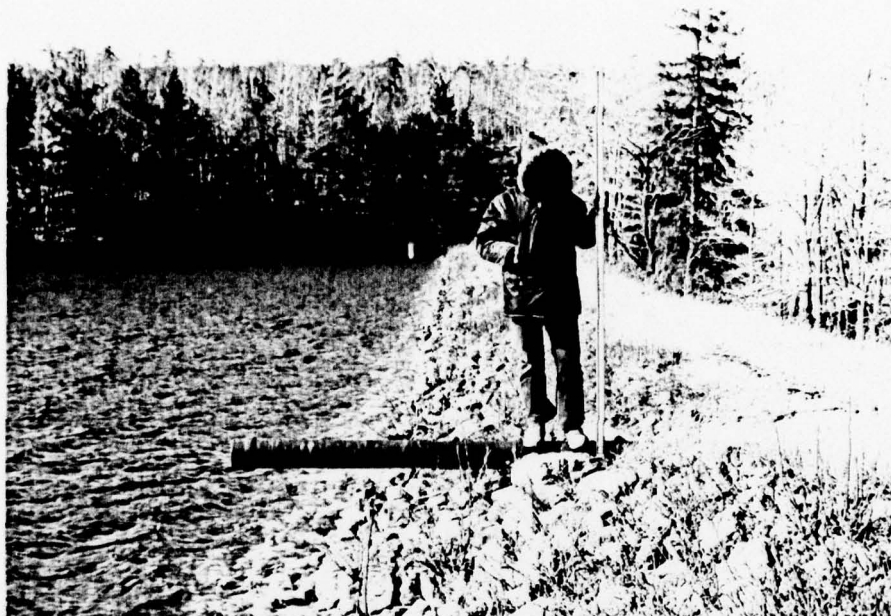
Deteriorated
concrete core-wall, low
areas, pipe through em-
bankment.

C. Pipe through Embankment

(6) Remove the pipe passing through the core-wall near the top of the dam. Repair the core-wall in this area.

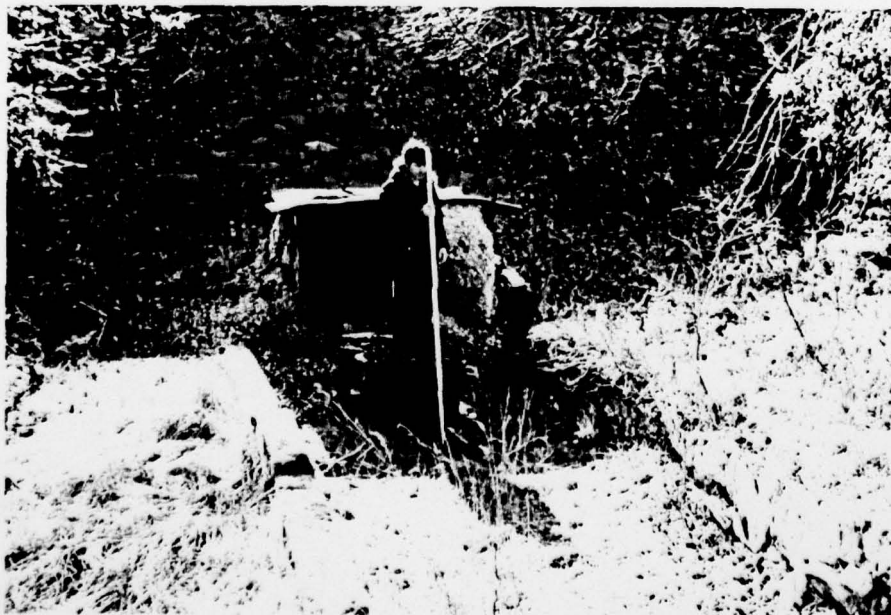
(3) Appurtenant Structures. The conditions at the emergency drawdown outlet works are an indication of lack of maintenance. Although the valve house has been repaired, the lack of ready access indicates a lack of concern for the functioning of this feature.

D. Outlet Works at Toe of Embankment

(3) Provide closure facilities for the outlet works pipes upstream of the concrete core wall for periodic inspection and for use in the event the pipes leak severely, thereby endangering the embankment.

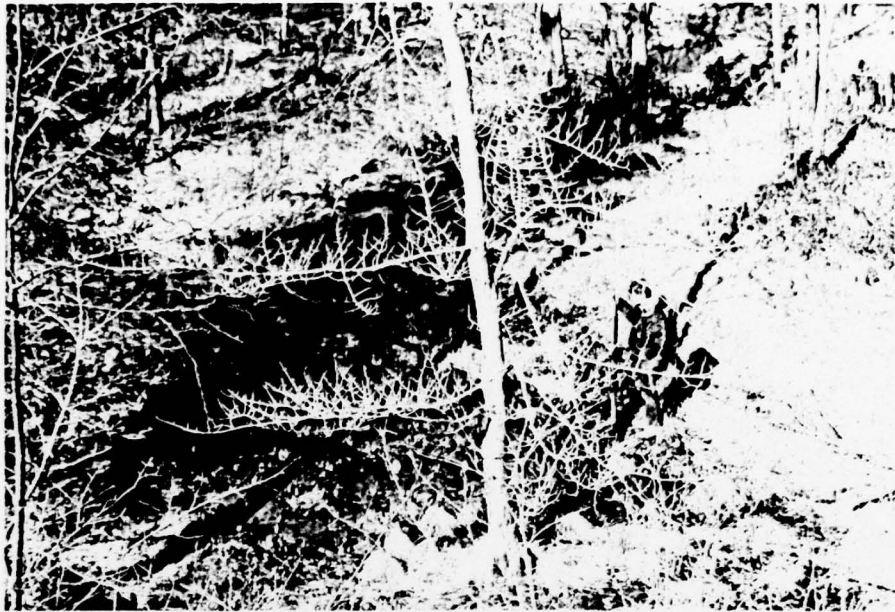
E. Wet Area at Toe of Embankment

(2) Engage the services of a professional engineer experienced in the design and construction of dams to perform the following studies: a study to more accurately determine the spillway capacity required at the dam and to determine the measures required to make the spillway hydraulically adequate, a study to determine the structural factors of safety for the embankment and the best means to raise the embankment to its design elevation, a study to determine the best means of making the outlet works operational, a study to repair the deficiencies in the spillway area, and a study to determine the best means of continually monitoring the wet areas at the dam. These studies will require, as a minimum, installation of observation wells or other instrumentation to determine water levels in the embankment, an exploration program to determine the engineering properties of the embankment and foundation materials, a complete survey of the embankment and adjacent area, and grading of the area downstream of the toe to more accurately assess the wet areas. Take appropriate action as required.

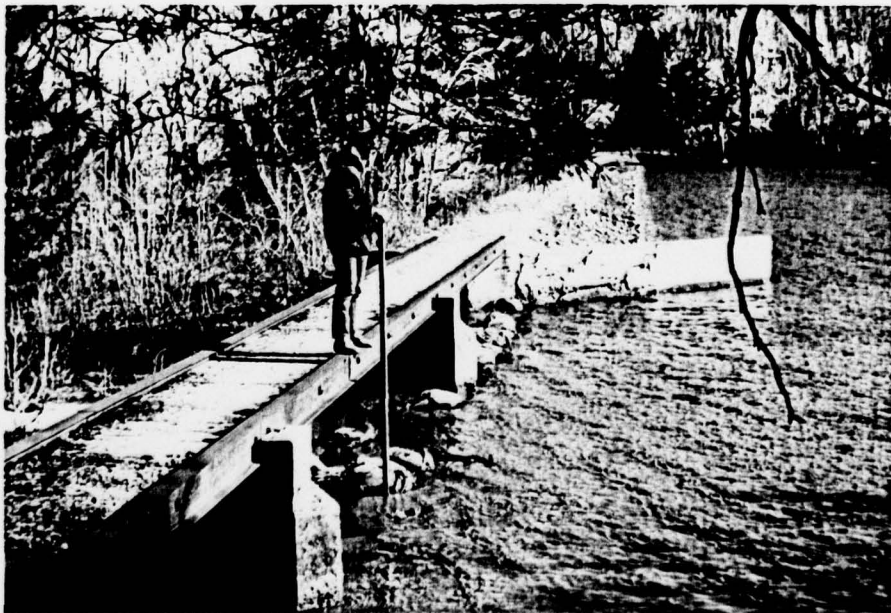
The spillway is in fair condition. A few sandbags are placed sporadically across the crest (Photograph F). The remnants of others are at the toe of the spillway chute. The right spillway approach wall is peeling badly in areas. The left approach wall is spalled and peeling. The entire slab of the chute is scoured. One area is scoured 1.5 feet deep and the adjacent left wall is undermined for 2 feet (Photograph H). Where the wall is undermined, a 25-foot length of the wall has a near-horizontal crack with a 0.2-foot offset (Photograph G). The right wall of the chute is spalled and peeling. Trees are growing behind this wall. At the spillway crest, the bridge piers are in good condition. The low steel of the bridge is at the design elevation of the top of the dam. The bridge deck is missing for about a 4-foot length. The remainder of the deck is deteriorating.

The Owner has used sandbags to increase the storage at other dams in his system. As noted in Paragraph 3.1c, a few sandbags are on the spillway crest and the remains of other sandbags are at the downstream end of the spillway chute. It is surmised that these sandbags are used to increase the storage. The use of sandbags on the spillway crest is a serious hazard to the dam.

F. Spillway Crest

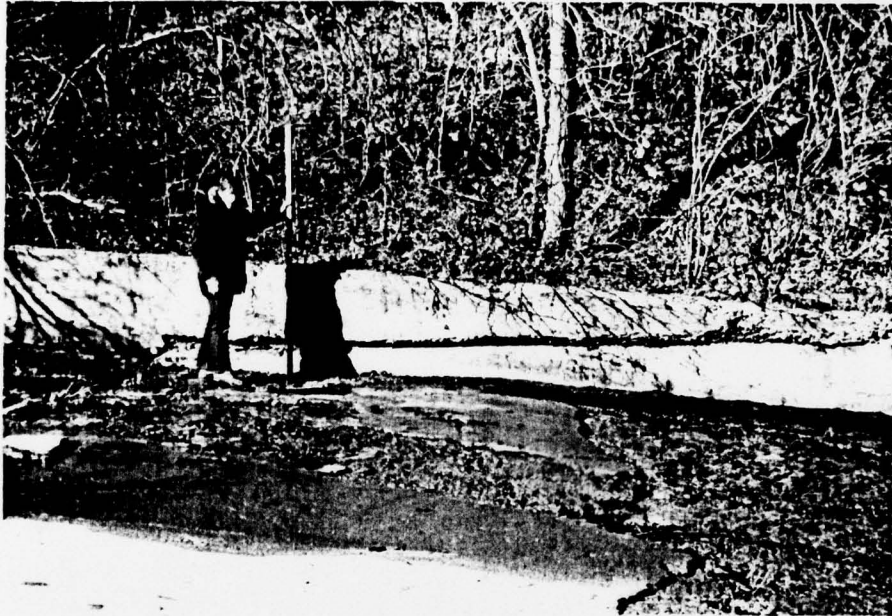
The lack of contraction or expansion joints has contributed to the conditions in the spillway. Most of the conditions are an indication of the lack of maintenance. The crack, scour, and undermining near the left wall indicate that the wall may be near failure.

G. Crack in Left Spillway Wall

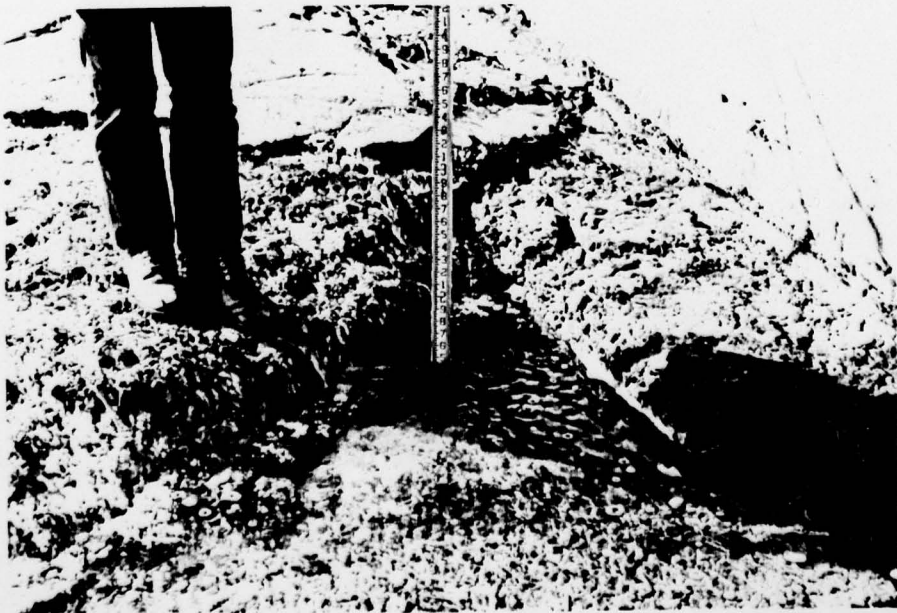
This would not be an immediate hazard to the dam, except it might cause the hillside to partially slide into the chute. This could interfere with flow in the chute.

H. Scour Hole at Left Spillway Wall

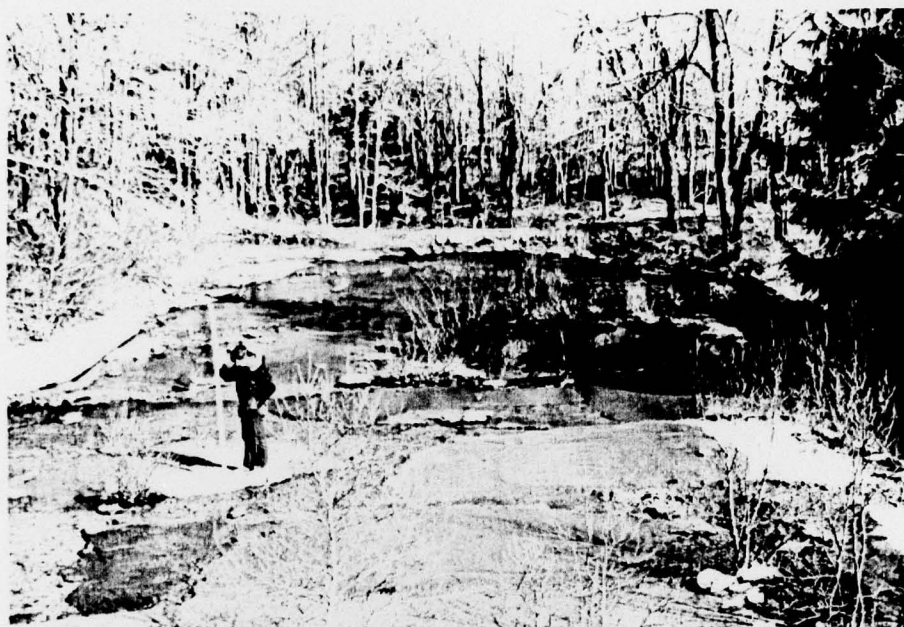
I. Spillway Chute

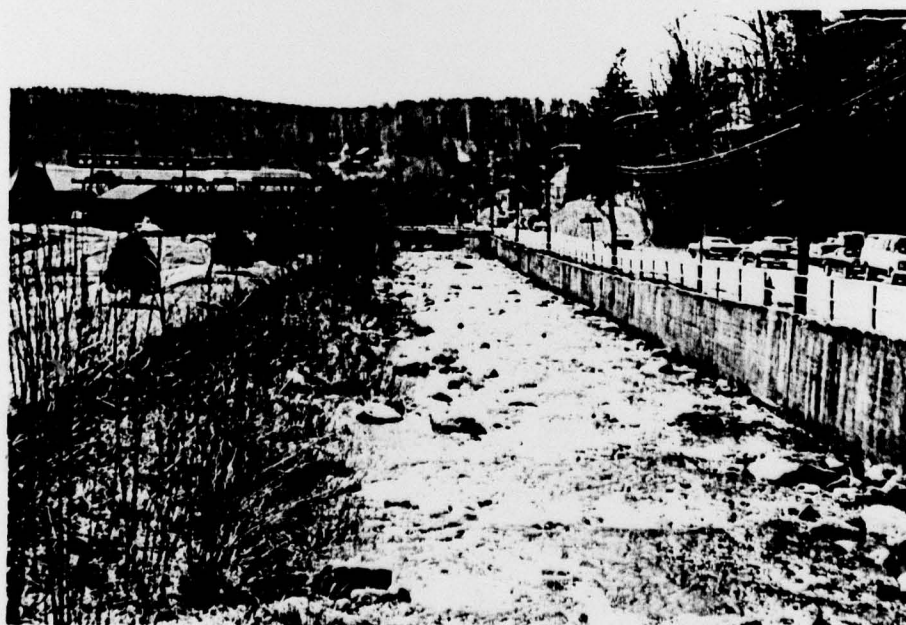
e. Downstream Conditions. From Dam G, the stream flows for 1.2 miles, along an uninhabited and wooded reach, to its confluence with Hazle Creek. In this reach it crosses under what apparently is a low railroad embankment. Hazle Creek flows for 4.3 miles, along an uninhabited and wooded reach, to the community of Weatherly, where at least 40 dwellings are within the floodplain.

J. Weatherly - downstream of Dam G
